NT PLANNING COMMISSION HEARING

PROPOSED NT PLANNING SCHEME AMENDMENT PA2025/0376

Rezone Lot 4360 Town of Darwin (12 Dinah Beach Road, Darwin City) from Zone GI (General Industry) to Zone MR (Medium Density Residential) and Zone HR (High Density Residential)

Report to the Planning Commission

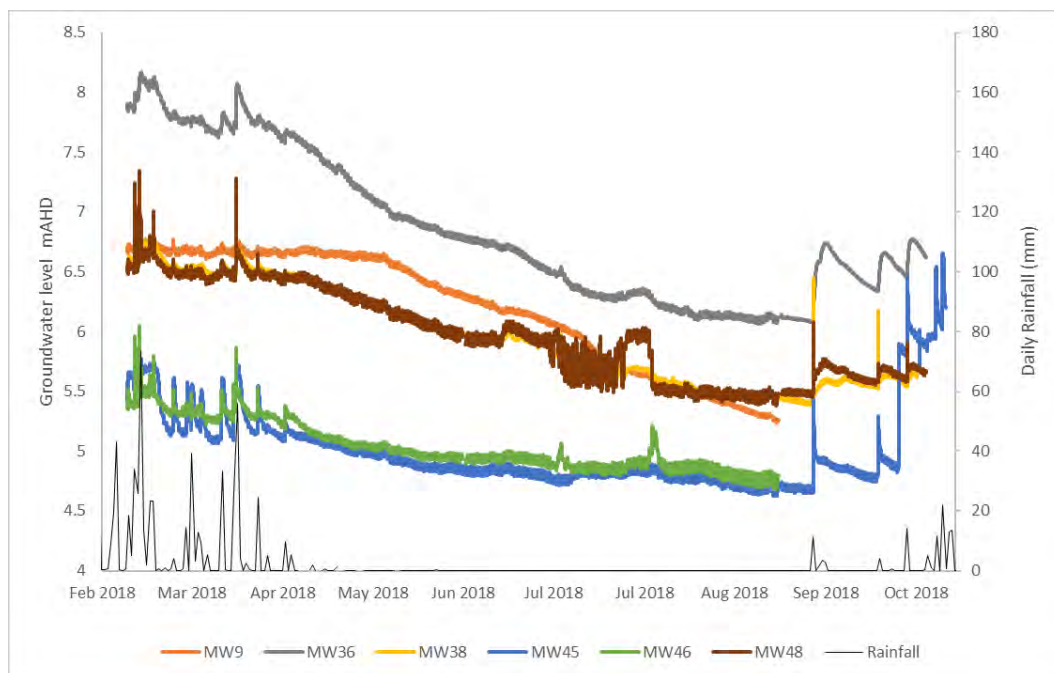
Figure 4-1: Groundwater levels and rainfall across the site in 2018.

Levels fluctuate seasonally in response with the monsoonal rainfall patterns observed in Darwin and the NT, with lower groundwater levels reported in the dry season (refer to **Figure 4-1**).

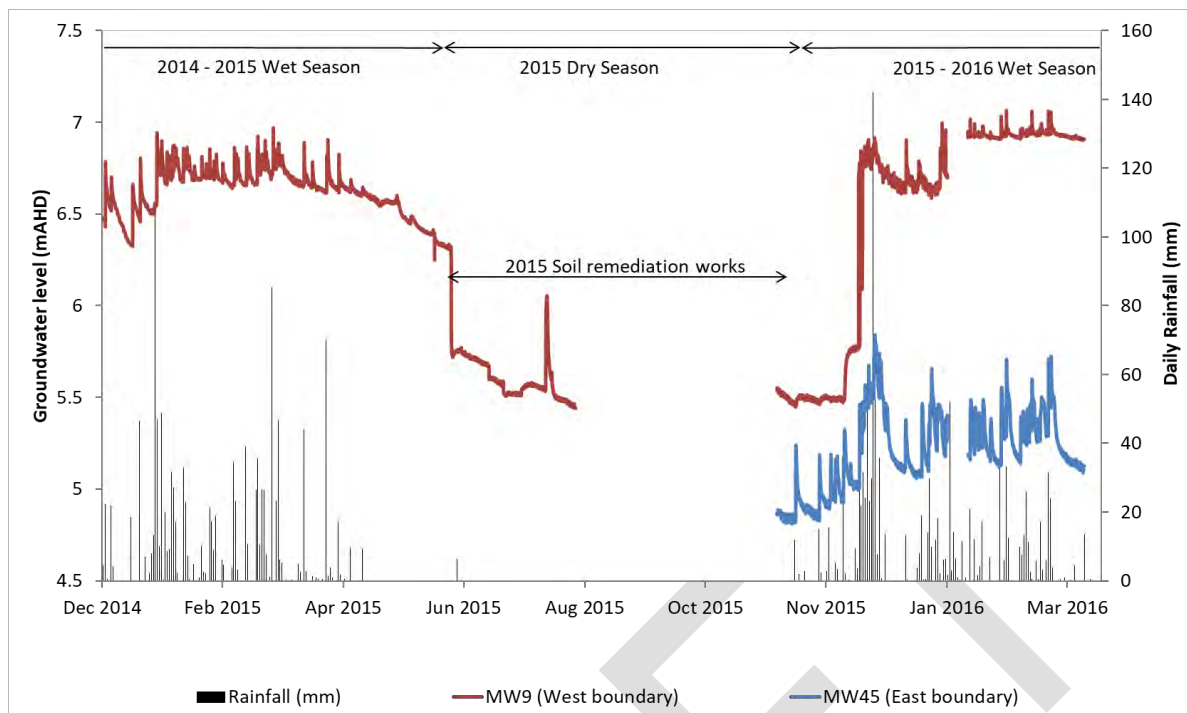
Figure 4-2: Rainfall and groundwater levels from 2015 to 2016 on the western and eastern boundaries.

Figure 4.2 and Figure 4.3 present the relative difference in groundwater levels from west (MW9) to east (MW45) across the site in 2015 when soil remediation works were undertaken, and in 2018 representing current groundwater levels. Groundwater level hydrographs showing levels in selected monitored wells are provided in Appendix E, the survey data for monitoring wells is presented in Appendix F and historical gauging data for the site is provided in Table 8 (Appendix B).

The groundwater levels during and post remediation indicate a strong, and rapid response to rainfall events, particularly on the eastern boundary in MW45 adjacent to the creek where the lithology is typically sandier, and permeability is higher in the wet season (discussed further in Section 4.3.6).

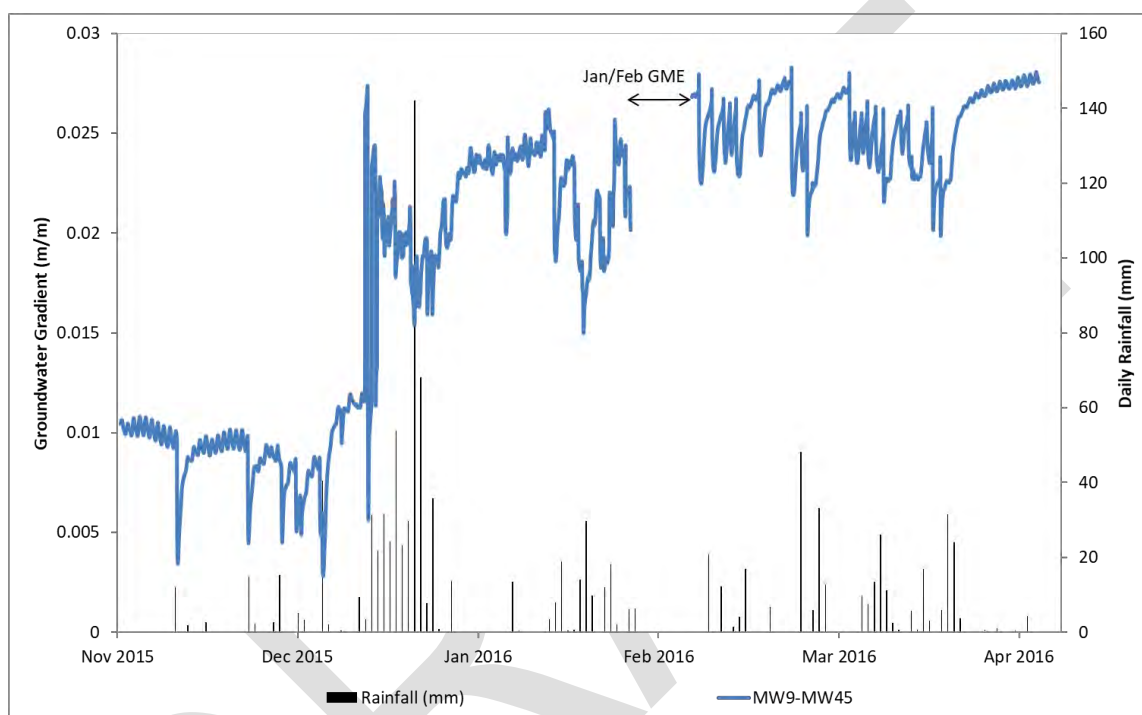
The gradient over time from the western boundary (MW9) to the eastern boundary (MW45) across the site appears to double in the wet season (Figure 4-5 below). Gradient trends for two additional transects across the site; MW2 to MW45 (centre to north) and MW36 to MW46 (south to centre of the site) show a similar increase in gradient during the wet season (refer to hydrographs provided in Appendix E).

Figure 4-5: Groundwater gradient, Wet season 2015/2016 (MW9 to MW45)

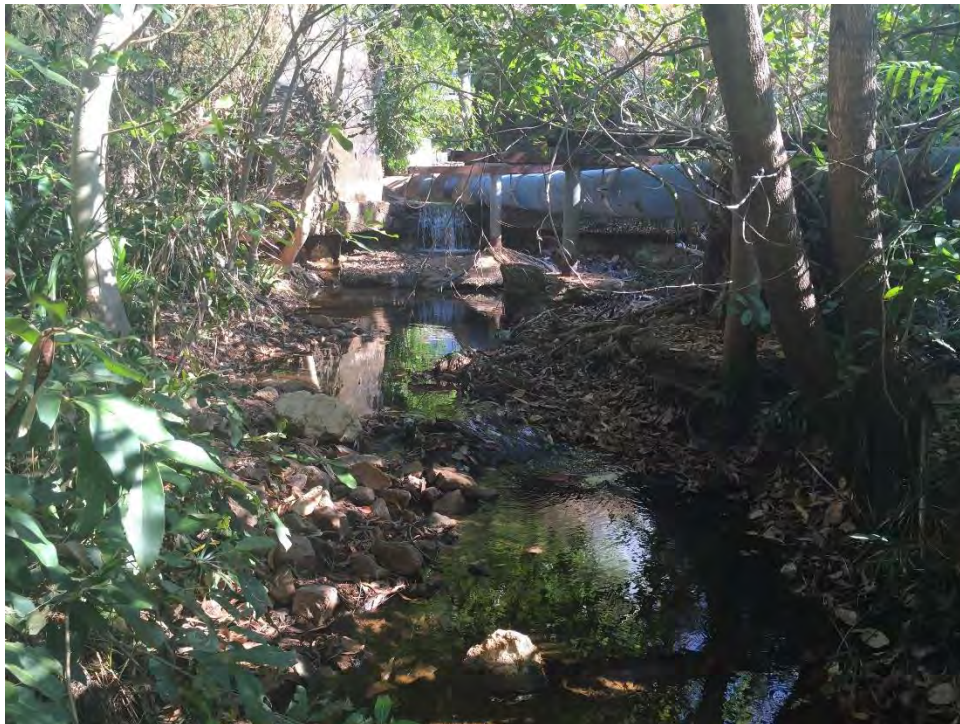
In the dry season, water is often still seen in the creek, which appears contrary to groundwater and creek invert level data indicating that the creek was not in connection with groundwater at this time. An inspection was undertaken of the extent of the creek along the site boundary to identify other possible water input sources. Water was found to be flowing into the creek from a drain beneath a concrete car park to the south of the site (near MW49), Figure 4-8.

Figure 4-8: Discharge from stormwater pipe to creek from car park to south of site.

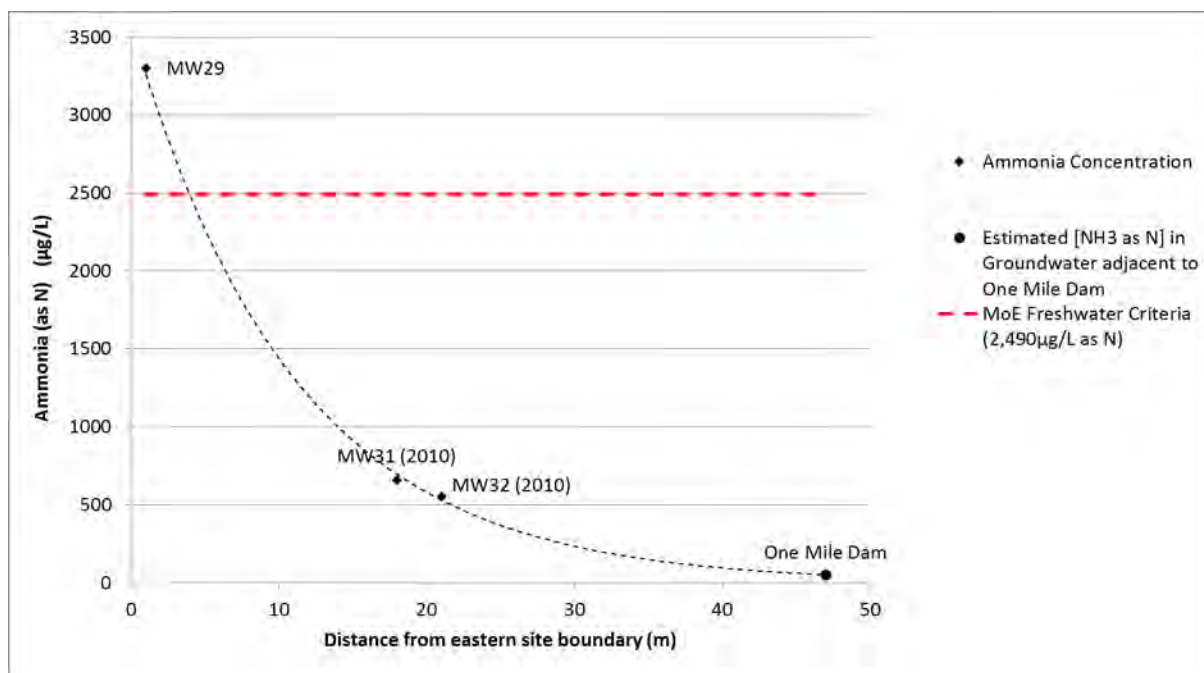
Ammonia concentrations in groundwater decrease with distance from the site (Figure 12-1), indicating that attenuation is occurring. The groundwater geochemistry in MW31(2010) and MW32(2010) is similar to on-site, albeit with a higher TDS, and appears to be reducing, indicating that the amount of nitrification occurring is likely to be limited to where oxygenated water mixes with ammonia impacted groundwater. The reducing conditions are also consistent with the low concentrations of nitrate reported in these wells, as TOC concentrations are relatively high (9 mg/L to 15 mg/L), and so where nitrate is produced it will rapidly be denitrified to nitrogen gas.

Figure 12-1: Ammonia concentrations with distance from the eastern site boundary, and predicted concentration at One Mile Dam.
